DDAS Accident Report

MINE INCIDENT REPORT 003/2007

Report on the BAC INCIDENT that occurred on the 03rd April 2007 in which an M77 Sub-Munitions was located adjacent to CBU site 203.

INDEPENDENT INVESTIGATION REPORT FOR MINE INCIDENT IN BATOULAY - 03 April 2007, No 003/07

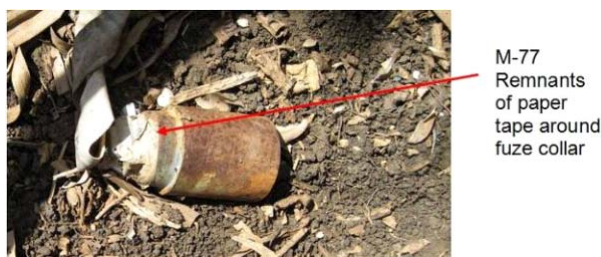
In order to determine the exact location of the M-77 it was necessary to utilize the completion report map / coordinates, compass and measuring tape to identify the task perimeter. Using the completion report cleared area perimeter coordinates it was possible to navigate from the Start Point with some accuracy using the compass and measuring tape. The location of the Start Point and Turning Point (TP) 1 were each marked with a metal picket sunk in the ground. It was not possible to locate the metal pickets which had been used to mark Turning Points 2 and 3 however; the approximate location was identified using the compass and measuring tape. The distance and bearing from TPs 2 and 3 to the M-77 were as follows:

TP 2 – M-77 = 346° / 24.4 m: TP 3 – M-77 = 186° / 24 m

According to the navigation conducted during the investigation, the M-77 is located to the west and outside task CBU-203 cleared area.

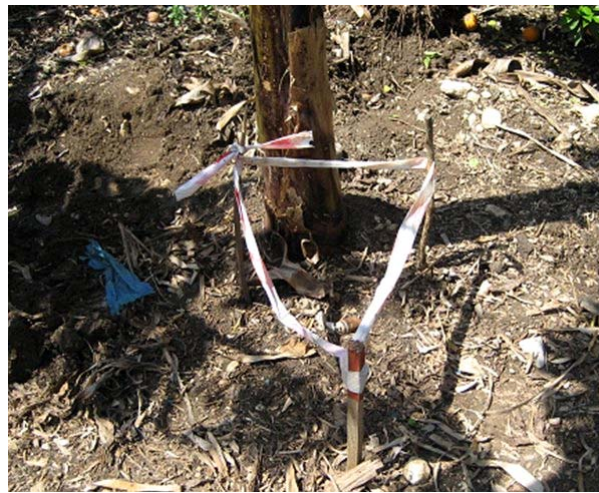
Photograph of Incident Site

The M-77 was on the surface positioned on its side. The submunition was complete with the ribbon attached and some remains of paper tape were attached around the fuze collar. Three wooden pickets and hazardous marking tape were positioned around the item to mark its location.

The M-77 was on the surface with remnants of paper tape around the fuze collar.

International Mine Action Organisations operating in Lebanon generally use plastic tape when rendering safe (gagging) submunitions therefore, it unlikely that the tape had been placed by them.

It is of the MACC SL investigation team's opinion that the M-77 was not discovered within Task CBU-203 cleared area and therefore, not missed during [Demining group] clearance operations of CBU-203.

The primary cause of this incident is listed as “Inadequate survey” because the item was found on the boundary of a cleared area, so the hazardous area should have extended further. The secondary cause is listed as a “Management control inadequacy” because the demining group’s perimeter marking had been so poor that it could not be found five months after leaving the site (it is intended to be “permanent”). This made it impossible for the investigators to be certain whether the submunition had been found inside the searched area or not. The use of appropriate marking systems is a management responsibility.

The presence of “gagging” tape around the neck of an obvious submunition found on the surface implies that it had been found and moved by someone – perhaps to discredit the demining group – and this may explain why the investigators did not criticise the demining group about its inadequate perimeter marking.

The M-77 is disposed of as a matter of urgency. [Name removed] has confirmed that [Demining group] will destroy the item in situation the same day.

Area reduction should be conducted in the immediate area of the M-77 to confirm whether there are additional submunitions. Surface BAC should be conducted out to a minimum distance of 25 metres from the item creating a 50 x 50 metre (50m²) box and or up to the perimeter of CBU-203 perimeter, whichever, is the greatest. It is recommended that due to the proximity of their current operations, [Demining group] be requested to conduct this.
